SAINT JOHN RIVER BASIN
Fort Fairfield, Maine

LAKE CHRISTINA DAM ME 00226

PHASE I INSPECTION REPORT NATIONAL DAM INSPECTION PROGRAM

SEPTEMBER 1981

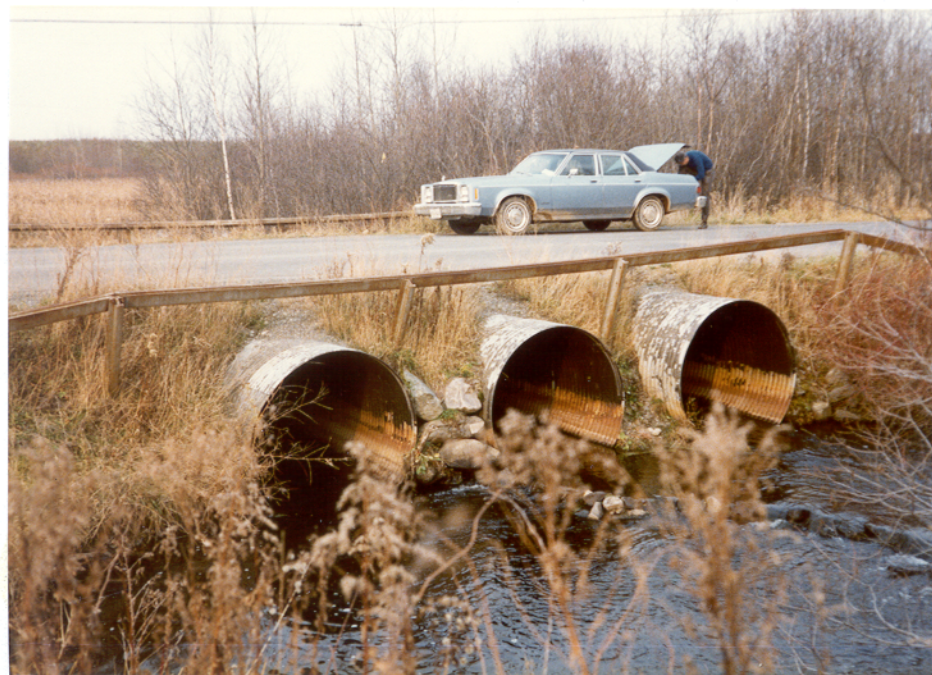
Photo 9

From the reservoir outlet to the Conant Road Crossing (photo 9) located about 250' away, the downstream channel (known as the Prestile Stream) was clear and flowing freely through the swamp. Further downstream, approximately two miles, is located the McCain Foods Processing Plant (seen in the background of photo 3). This draws a constant water supply from the Prestile Stream.

72"Ø Culverts
at Conant Road
(Note Dam in
Background)
